## 4. Structural Systems Performance

*The dominant causes of structural failure observed by the MAT included storm surge, waves, floodborne debris, and wind. Structural damage due to erosion was also common on the barrier islands. Damage occurred to residential buildings (single- and multi-family housing), commercial buildings, and critical and essential facilities.*

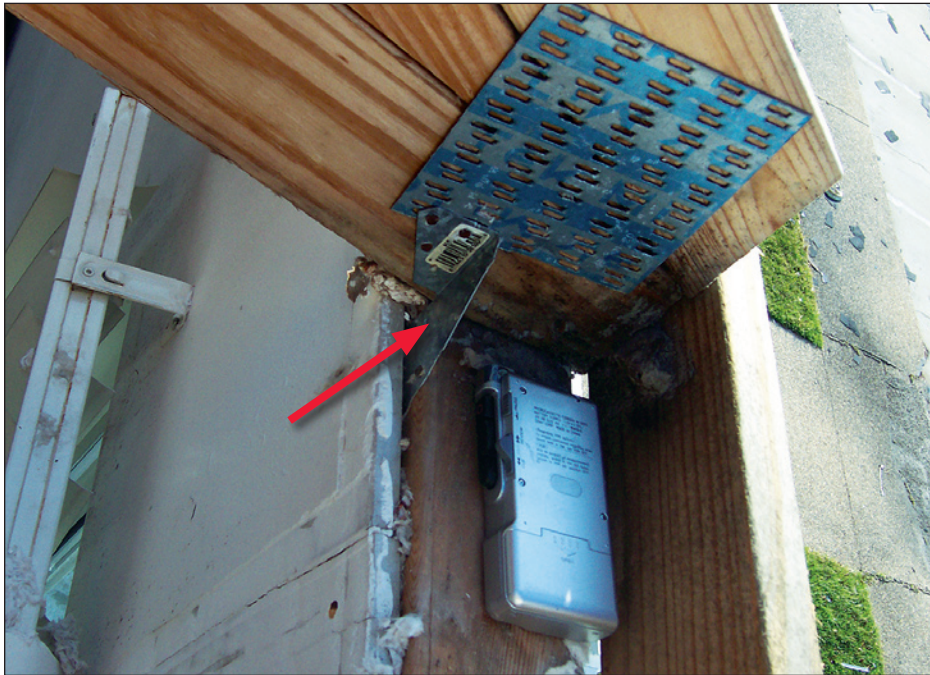
**Figure 4-95.**  
Metal connectors (arrow) were used on main trusses (estimated wind speed: 130 mph. inland Long Beach, Mississippi).

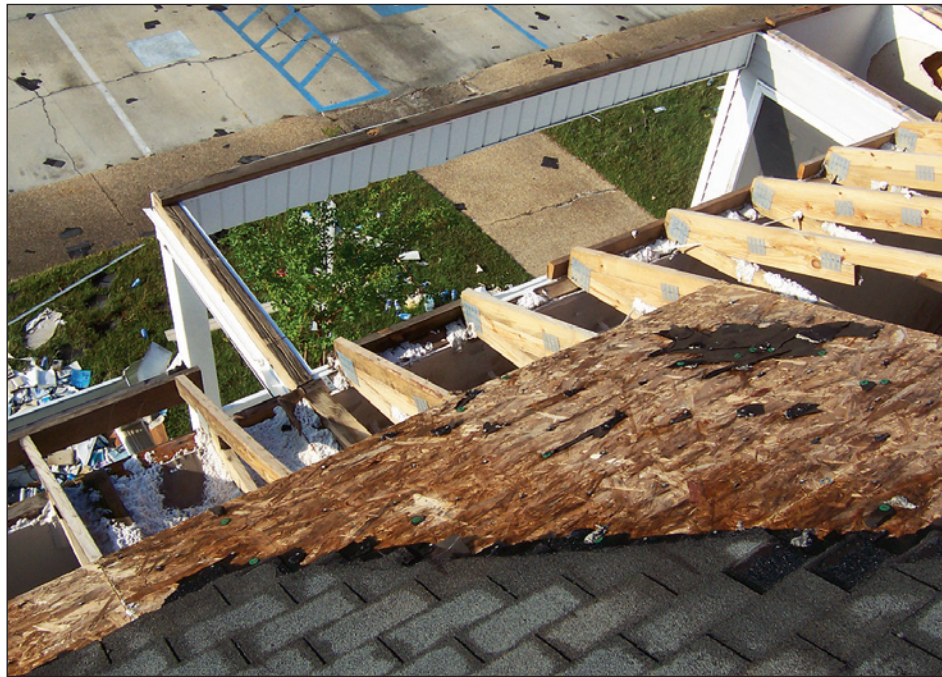
Figure 4-98.  
Apartment building's gable walls sheathed with insulation failed during Katrina (estimated wind speed: 130 mph. inland Long Beach, Mississippi)

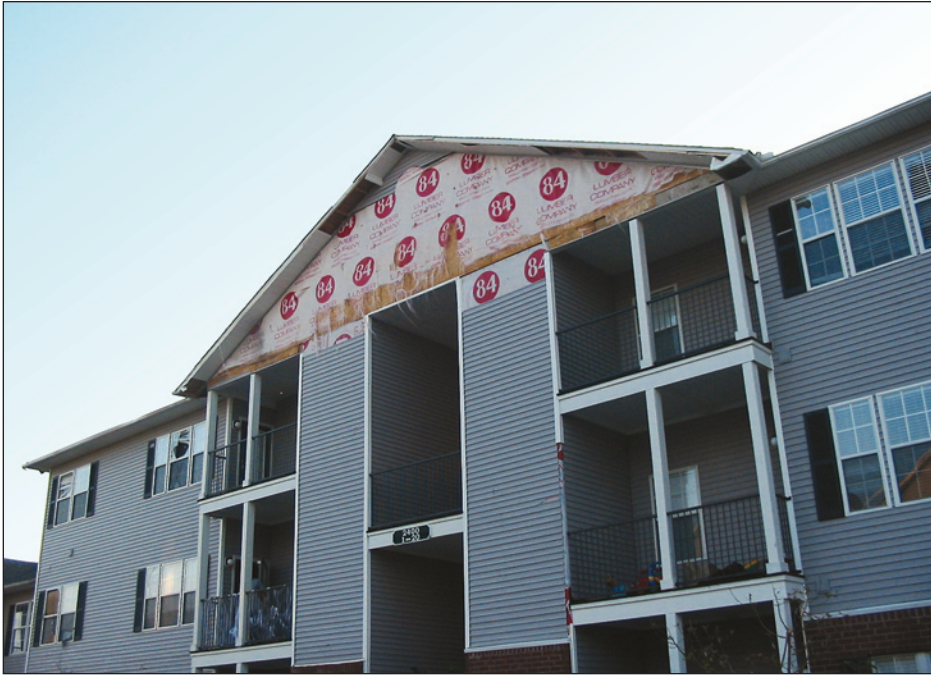
**Figure 4-99.**  
Apartment building with gable end walls that were constructed with OSB sheathing under housewrap (estimated wind speed: 120 mph. D'Iberville, Mississippi)

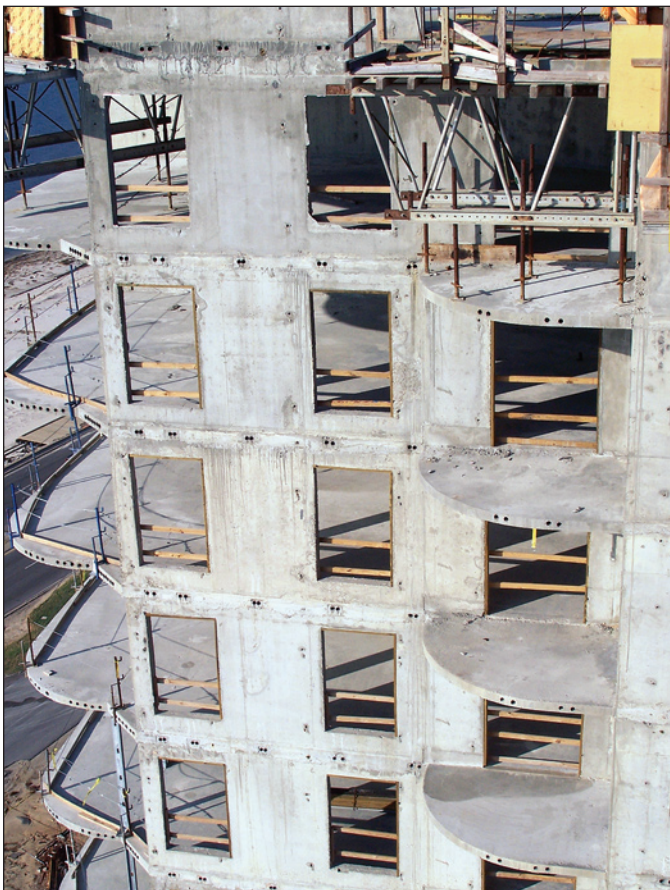
**Figure 4-111.**  
East tower located in Exposure C under construction with reinforced concrete and post-tensioned floor slabs. The east tower was water-inundated on the first floor and suffered only minor wind damage to the roof covering of the finished tower (estimated wind speed: 120 mph. Biloxi, Mississippi).

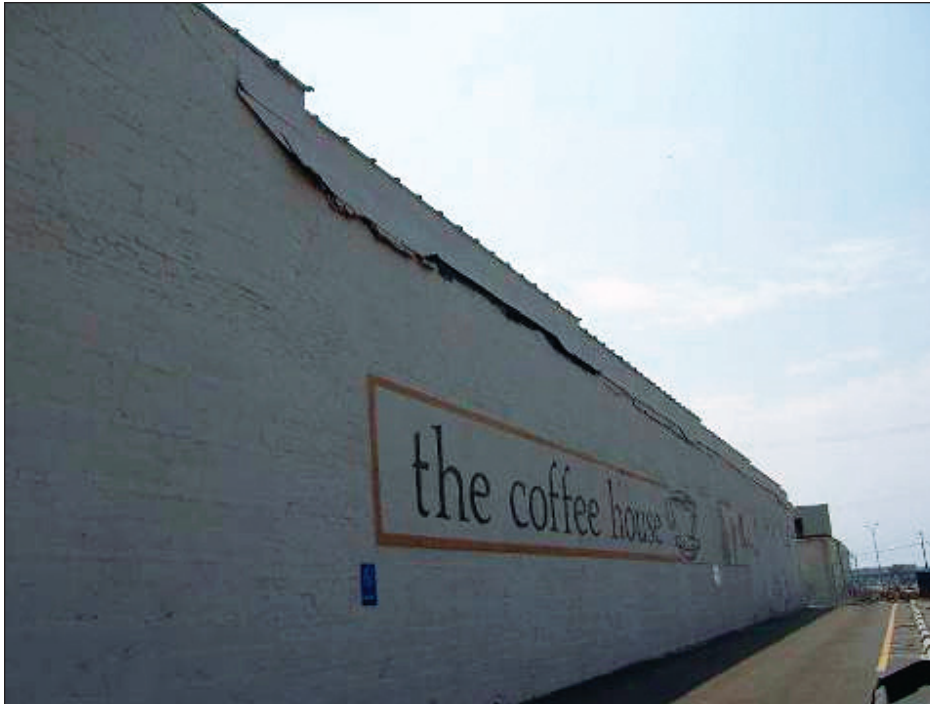
Figure 4-114.  
Unreinforced masonry  
parapet failure on a  
building located in  
Exposure C (estimated  
wind speed: 130 mph.  
Gulfport, Mississippi)

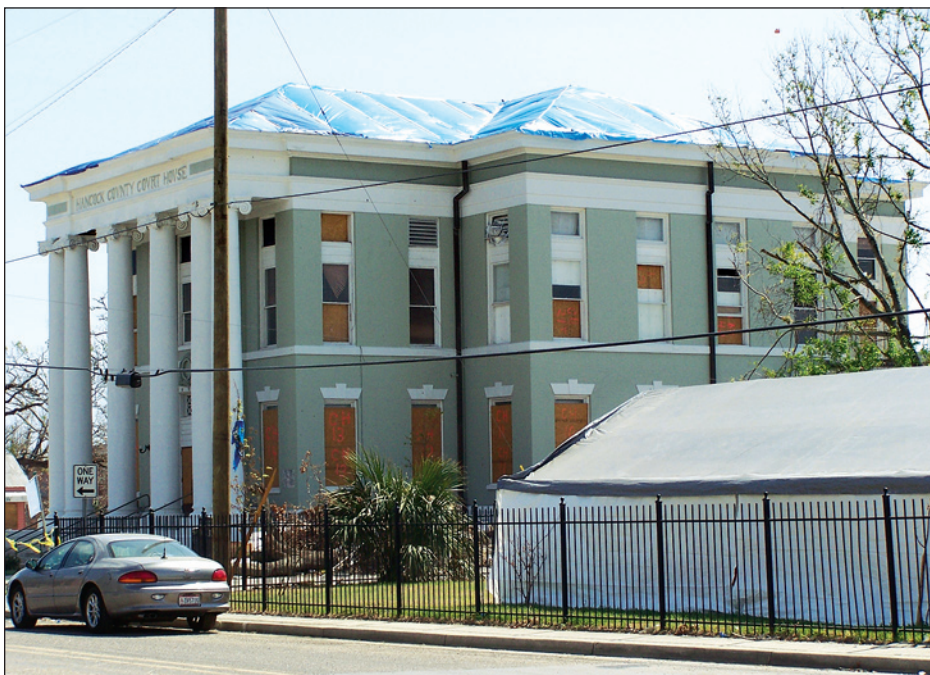
Figure 4-115.  
Hancock County  
Courthouse located in  
Exposure C with roof  
and windows damaged  
by wind and windborne  
debris (estimated wind  
speed: 125 mph. Bay St.  
Louis, Mississippi)

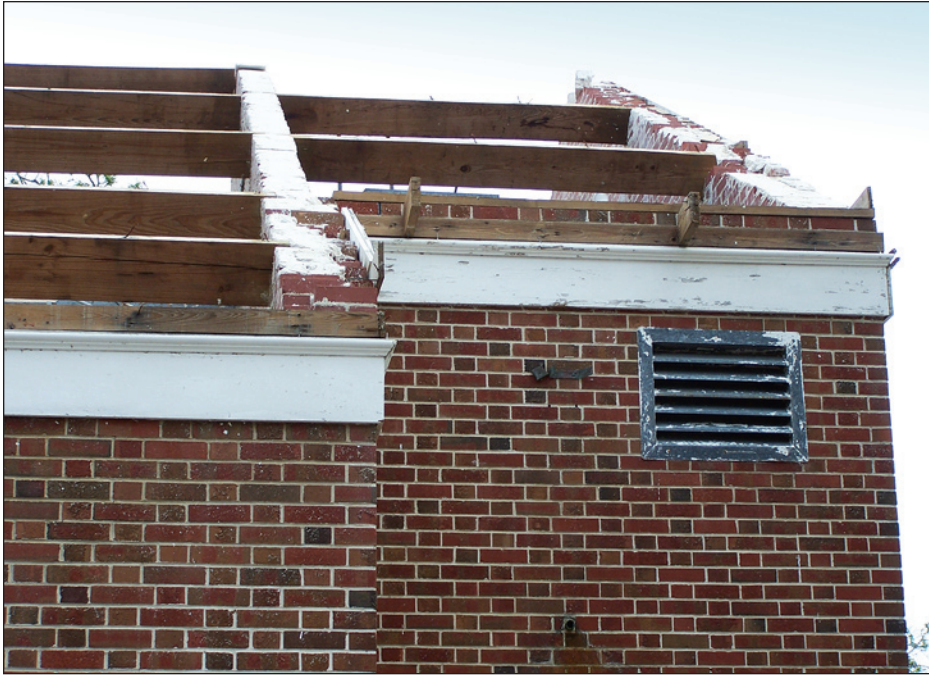
Figure 4-118.  
Grouted multi-wythe  
masonry walls. Note  
loss of roof decking  
(estimated wind speed:  
130 mph. Gulfport,  
Mississippi).

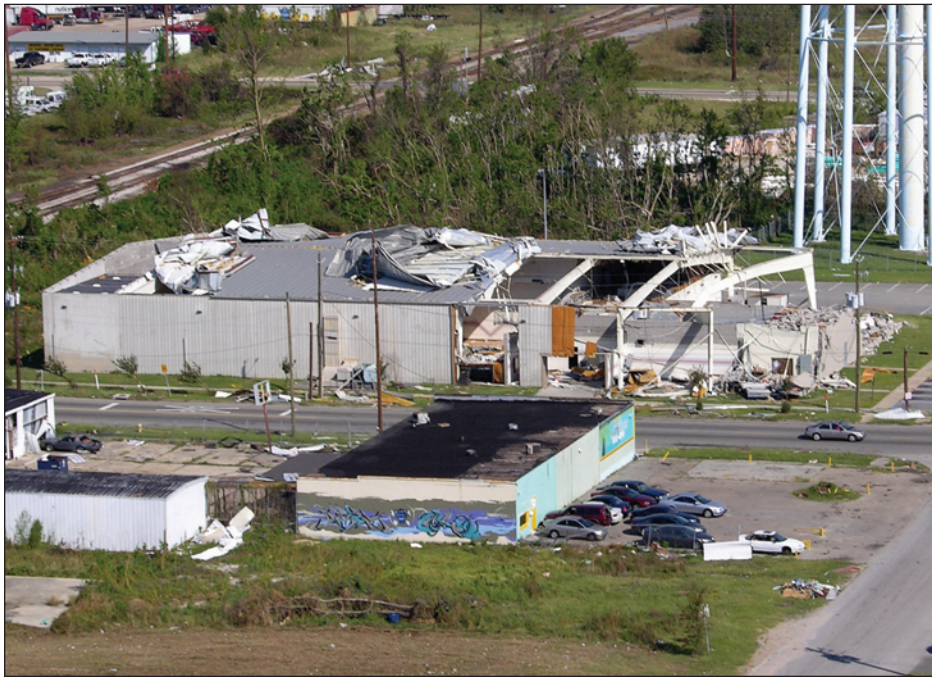
**Figure 4-122.**  
Failure of older (1974)  
pre-engineered metal  
building (estimated wind  
speed: 130 mph. Gulfport,  
Mississippi)
